# H O V E Y ENVIRONMENTAL

## RESIDENTIAL MOLD ASSESSMENT

### Final Report

September 1, 2003

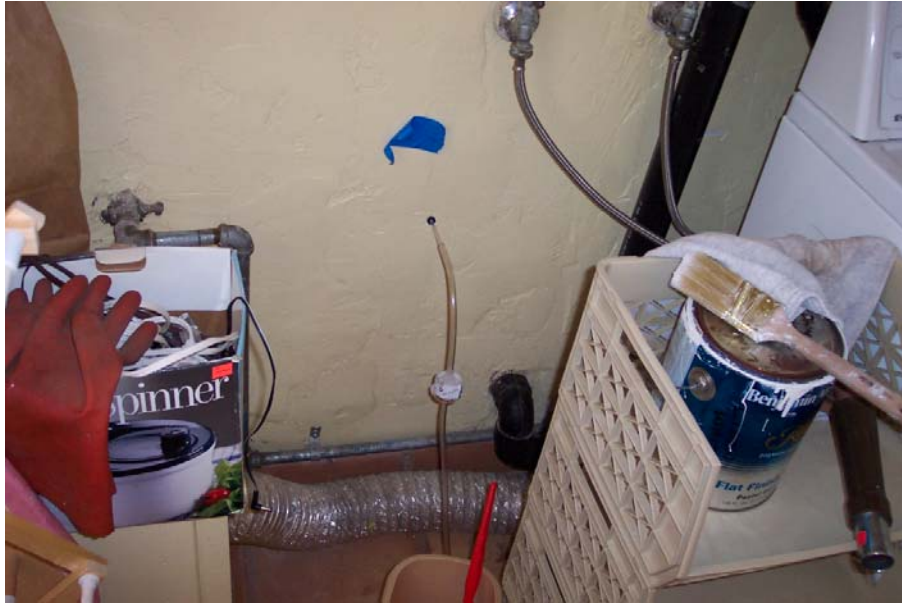
Several areas of elevated moisture and suspected mold growth were noted in the home. Most of these were surrounding plumbing areas, windows, or ceiling corners. In the laundry room, high

moisture levels were detected on the wall in the area the pipes go into the wall. A wall check sample was collected from this area (Figure 1).

Figure 1. Digital image of laundry room wall, showing sample location.

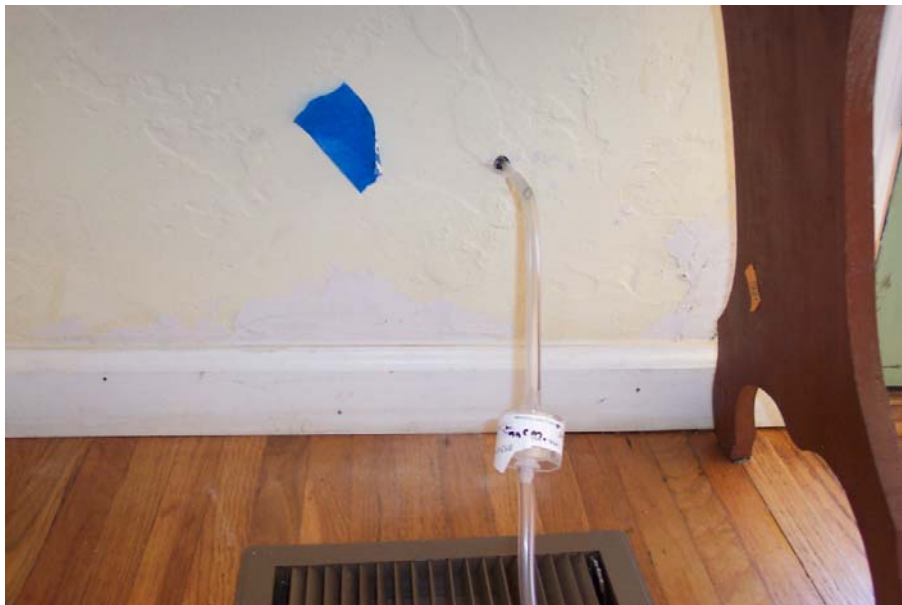
In the dining room, mid-level moisture was noted to the left and above the French doors. A wall check sample was taken to the left of the doors to determine if mold growth is associated with this moisture intrusion (Figure 2).

Figure 2. Digital image of sample taken left of French doors in dining room.

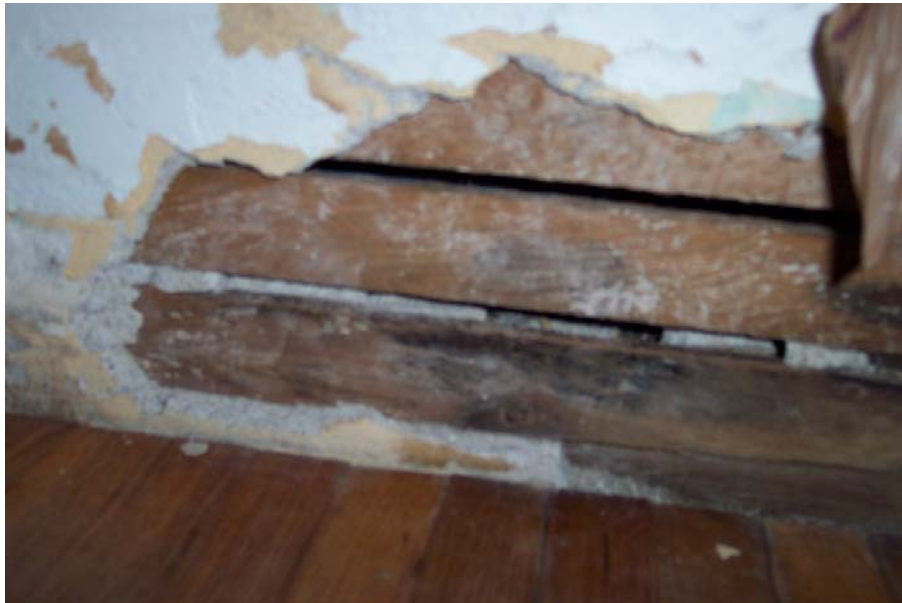
In the master bedroom, an area of drywall was removed from the wall common to the shower (Figure 3). Mold growth was noted on the lower boards of the wall cavity. Because mold growth was confirmed visually, a sample was not deemed necessary in this area. The relative moisture level of wood and dry wall in and above this area was high.

Figure 3. Digital image of area of removed drywall in master bedroom.

Active mold growth was confirmed around the showers in both the master bathroom and northwest bathroom. The source of moisture intrusion may be a deficiency in the shower pan, plumbing leak, or deficiencies in the grout of the tile surround. Mold remediation should proceed by removing the tile surround in both bathrooms in order to access all affected areas.

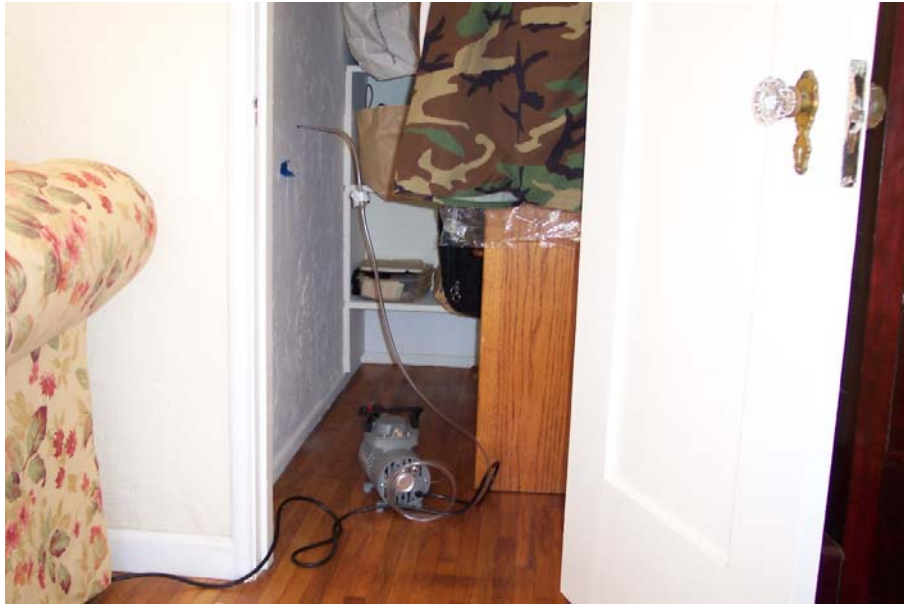
In the northwest bedroom, suspected water damage and stains were noted in the northwest and northeast corners of the room. Both of these areas showed low relative moisture levels. Additional moisture damage was noted around the window of the north wall. The relative moisture level of the drywall surrounding both bottom corners was high. High relative moisture levels were also detected in the closet. This wall is common to the master bathroom shower. A sample was taken from this area to determine if active mold growth is occurring behind the shower (Figure 4).

Figure 4. Digital image of wall check sample taken from closet of northwest bedroom.

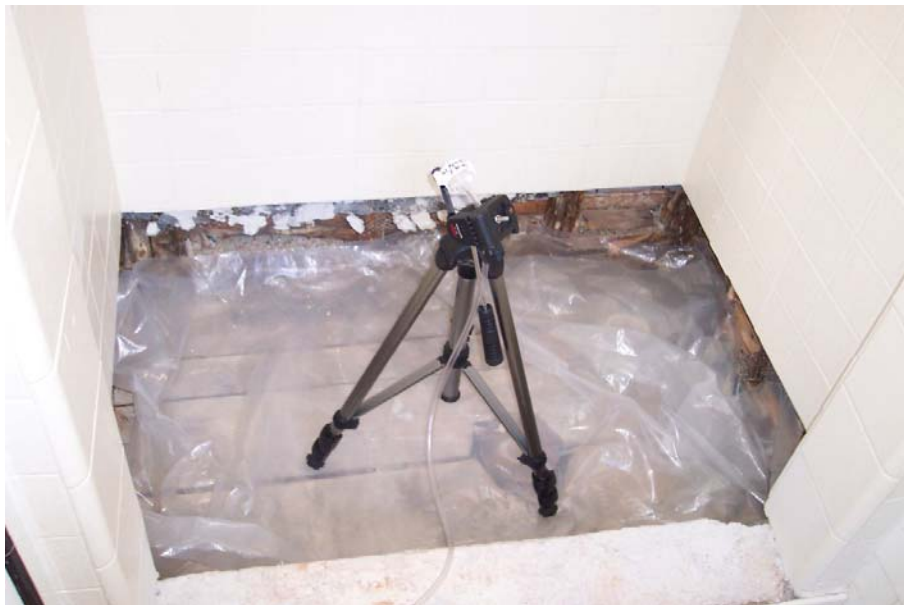
The bathroom adjoining the northwest bedroom has undergone some demolition. The tile surround in the shower had been removed from the shower floor and bottom foot of shower wall. High moisture levels were detected on the area of the hallway wall which is common to this shower. An ambient air sample was taken from this area to determine if mold is actively growing within the exposed wall cavities (Figure 5).

Figure 5. Digital image of sample taken in northwest bathroom.

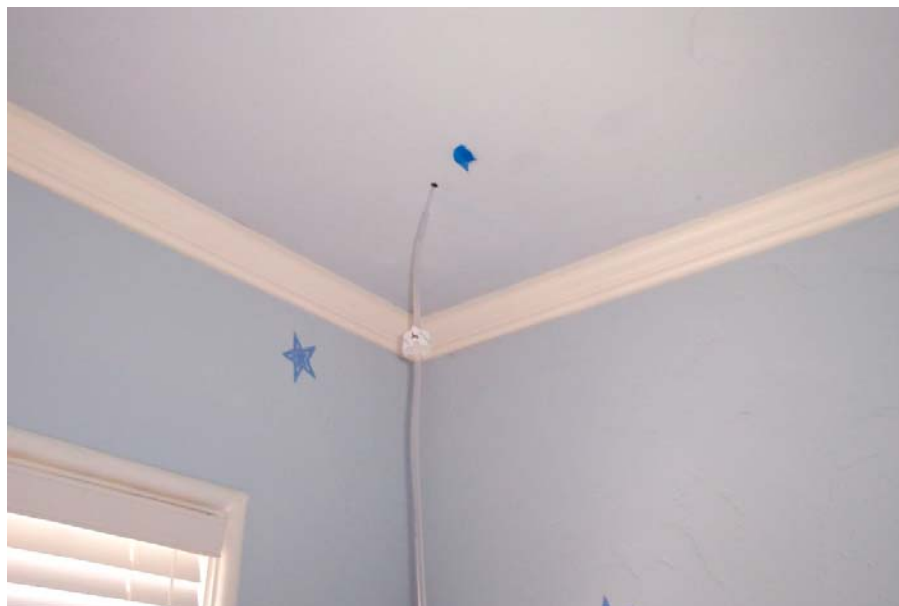
In the southwest bedroom (currently used as a child's room), a water stain was noted on the southwest corner of the ceiling. Relative moisture levels were slightly elevated in this area, and a sample was taken from the ceiling (Figure 6). In addition, mid-level relative moisture was detected around the south window.

Figure 6. Digital image of sample taken in southwest bedroom.

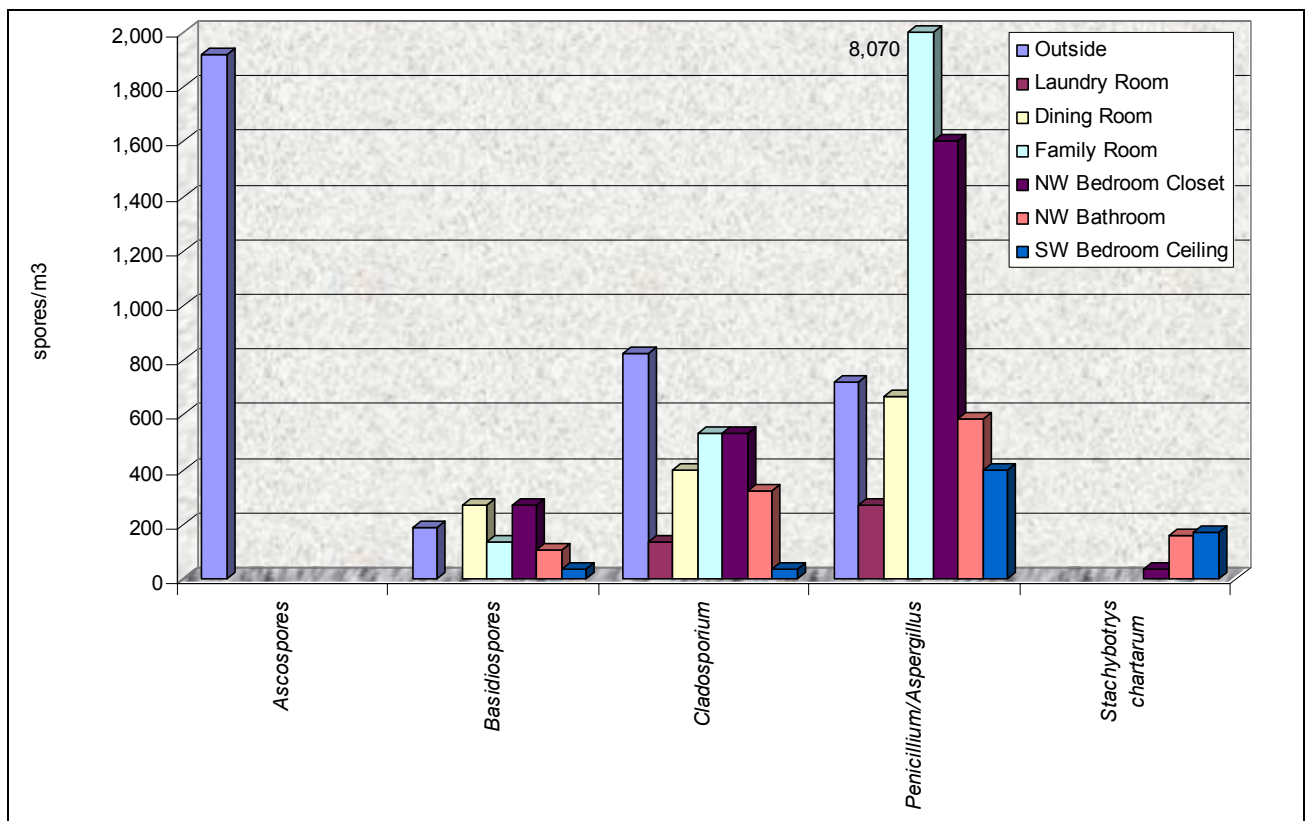
The concentration of individual mold types from each sample is given in Figure 7. In order to determine areas of elevated mold growth the concentration of individual mold types in each sample can be directly compared to the concentration of the same mold type in outdoor samples. In order to simplify the figure, mold types captured at low levels that are not significant in the analysis of active mold growth have been removed. The scale of Figure 7 was cut off at 2,000 spores/m<sup>3</sup> in order to show all trends in mold spore concentrations. The actual value of Penicillium/Aspergillus captured in the family room sample exceeded this level, therefore the value is provided on the graph.

Figure 7. Concentration of mold types in air samples.

Figure 7 shows a very high concentration of *Ascospores* captured in the outdoor sample. Because this value is so high compared to other mold types, the total concentrations provided in Table 4 cannot be relied upon to determine active mold growth. Further evaluation of each mold type is necessary. *Basidiospores* and *Cladosporium* were captured at inside at concentrations approximately equivalent to or lower than the outside sample. Active growth of these mold types is not occurring at the subject property. *Penicillium/Aspergillus* mold spores were captured at elevated concentrations in the samples taken from the wall of the family room and the wall of the Northwest bedroom closet. *Stachybotrys chartarum* was found in the wall of the northwest bedroom closet, the northwest bathroom, and the southwest bedroom ceiling. Active growth in the following areas has been confirmed by the concentrations of *Penicillium/Aspergillus* and *Stachybotrys chartarum*:

- Family room wall
- Northwest bedroom closet wall
- Northwest bathroom
- Southwest bedroom ceiling
